Photographs: **AMARILLO AIR TERMINAL BUILDING**

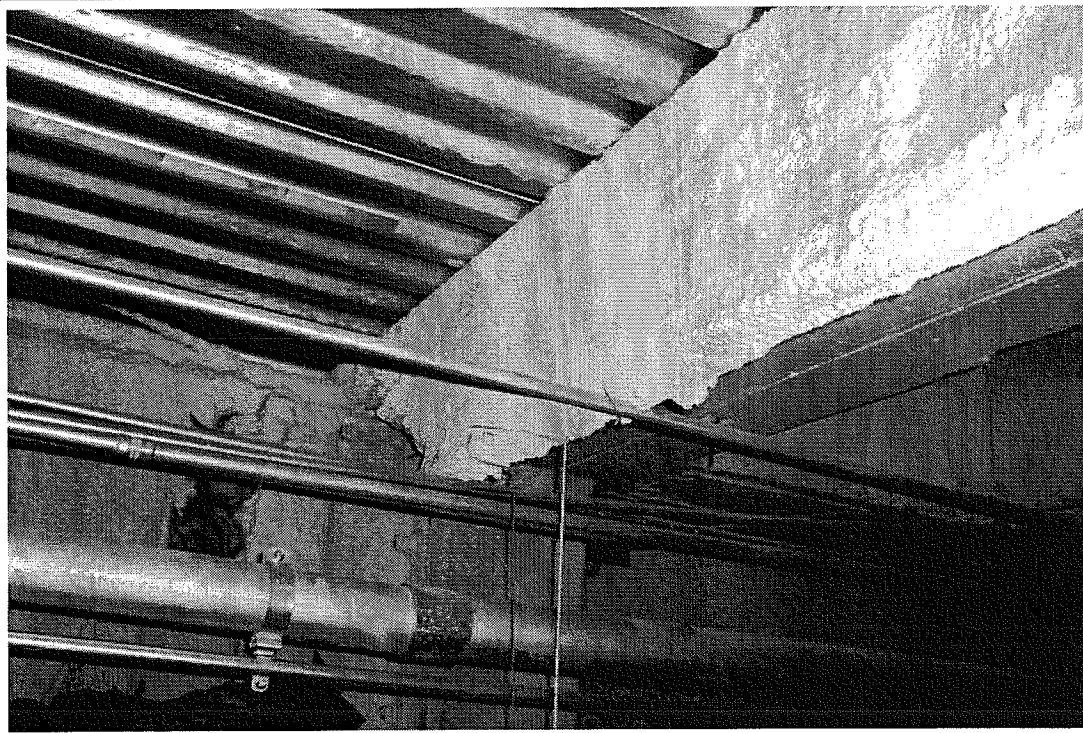
Photo 81. Concourse 30, 2nd floor, Airport Storage - General view of fireproofed beams and open web joists above suspended ceiling

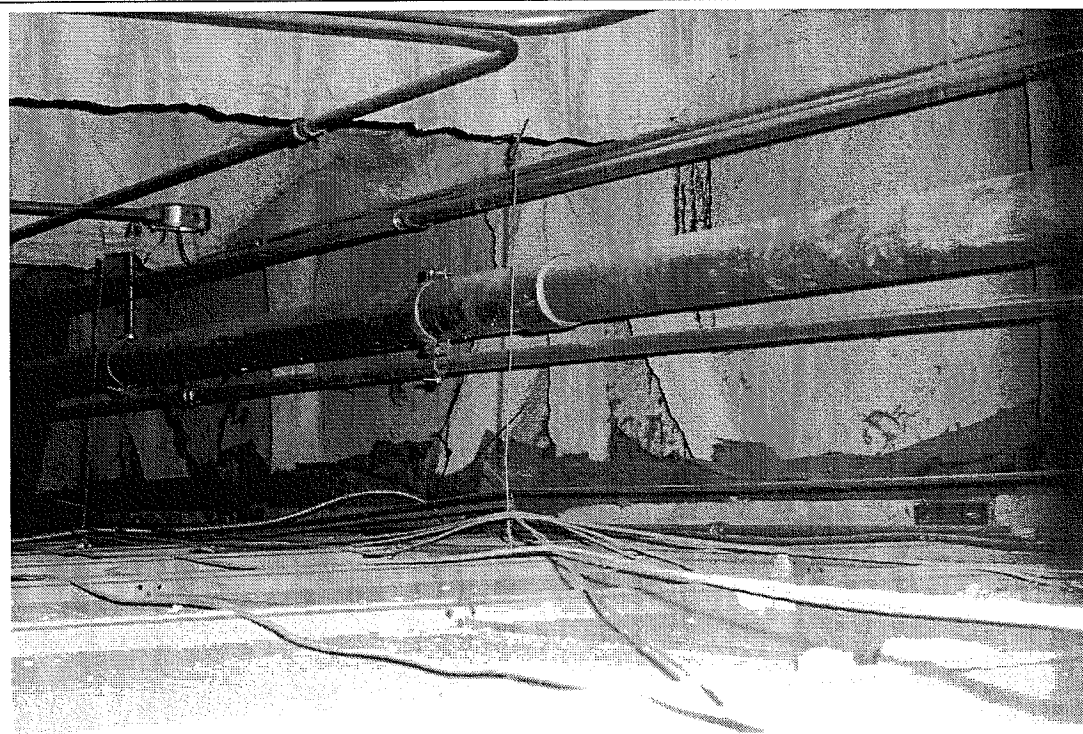
Photo 82. Concourse 30, 2nd floor, Airport Storage - General view of fireproofed beams and cross bracing along perimeter wall

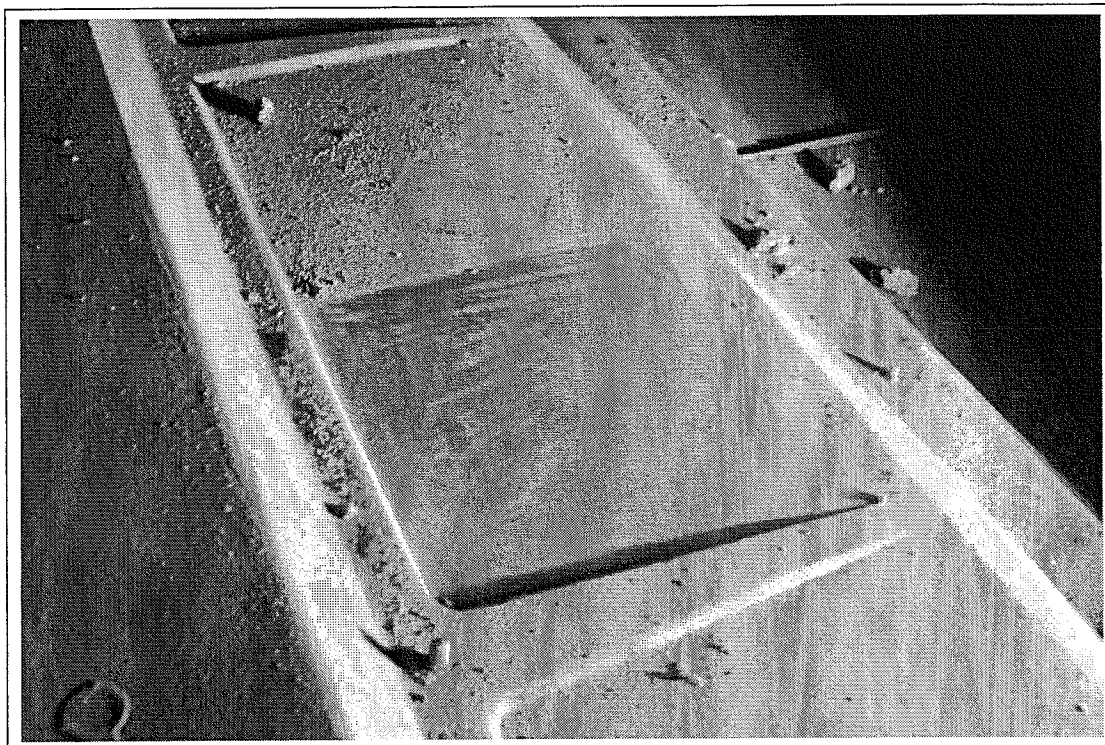
Photo 83. Concourse 30, 2nd floor, Airport Storage - Close-up of dust sample # 1 (top of fluorescent light fixture)

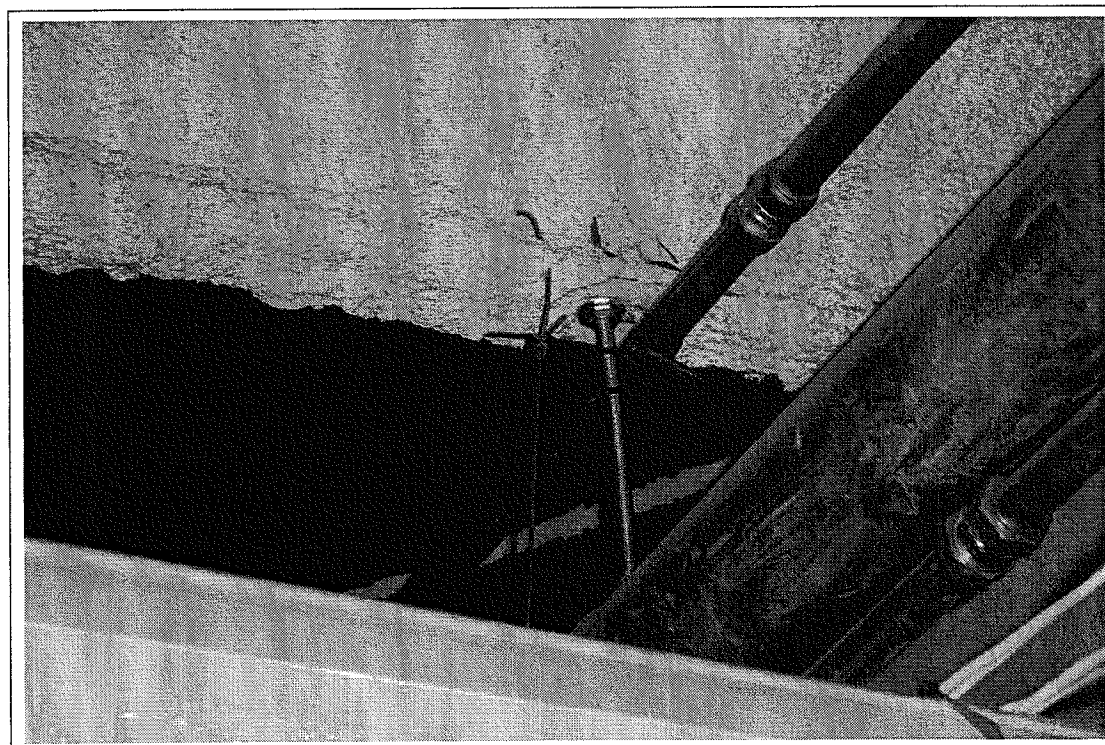
Photo 84. Concourse 30, 2nd floor, Airport Storage - View of impacted fireproofing above suspended ceiling

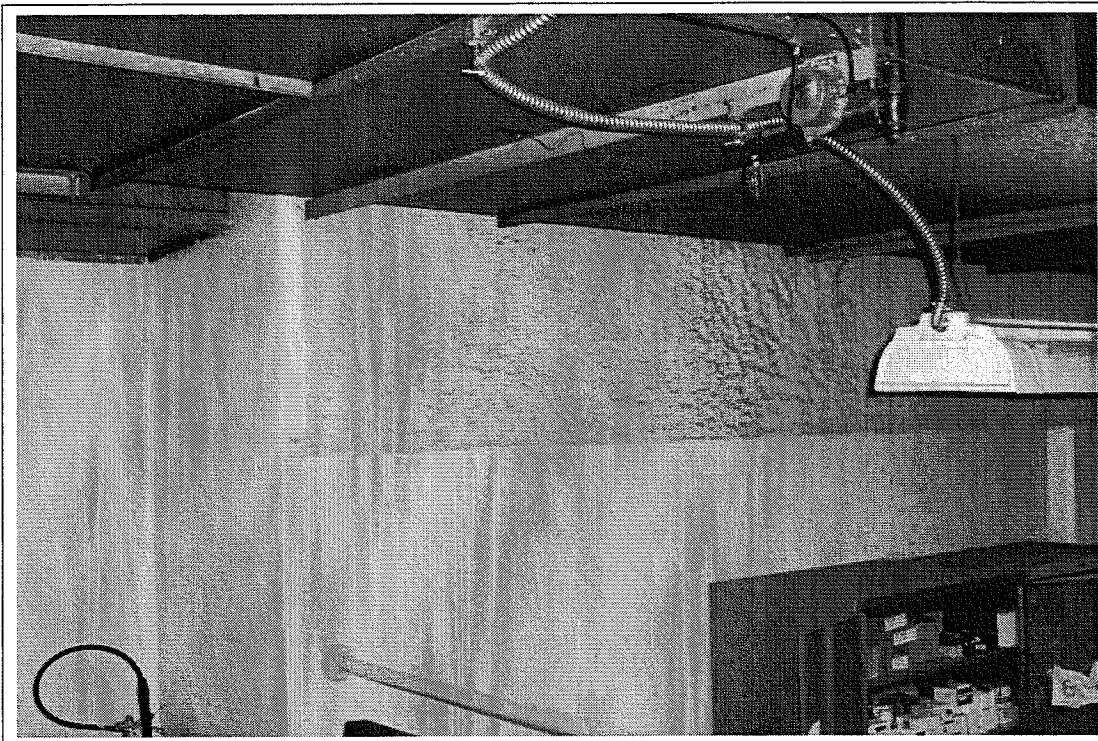
Photo 85. Main Terminal, Basement, Mechanical Rm - General view of fireproofed concrete beam adjacent to air handler

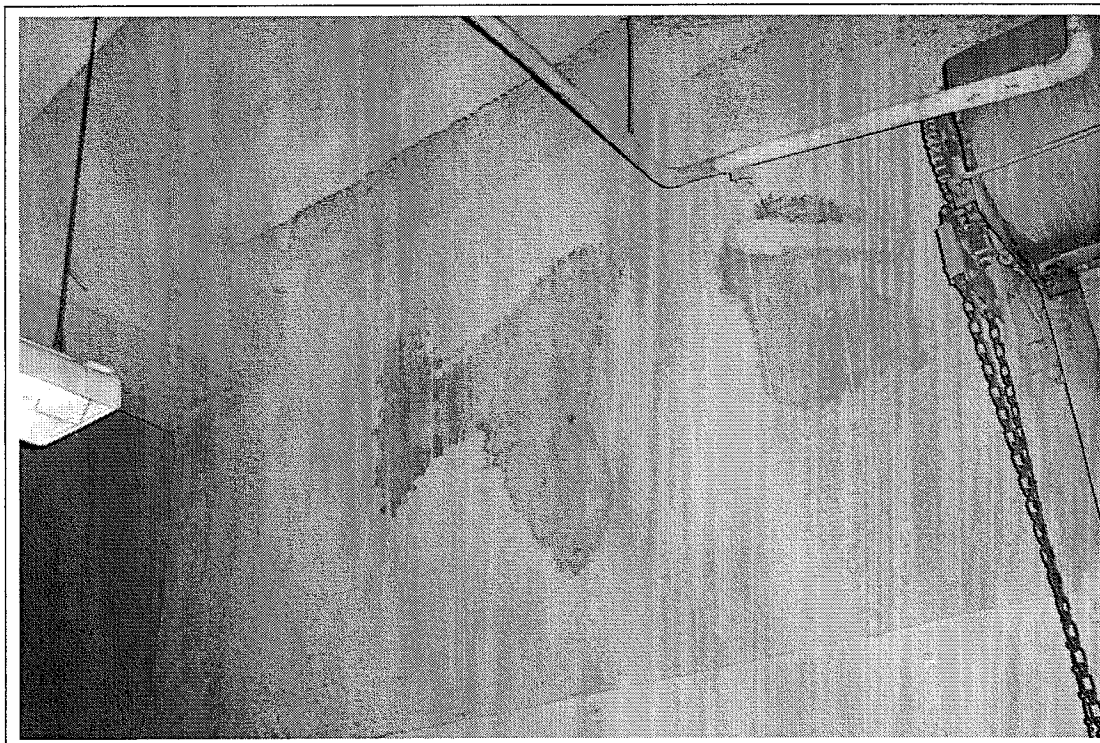
Photo 86. Main Terminal, Basement, Mechanical Rm - General view of delaminated fireproofed applied to wall adjacent to parts storage area

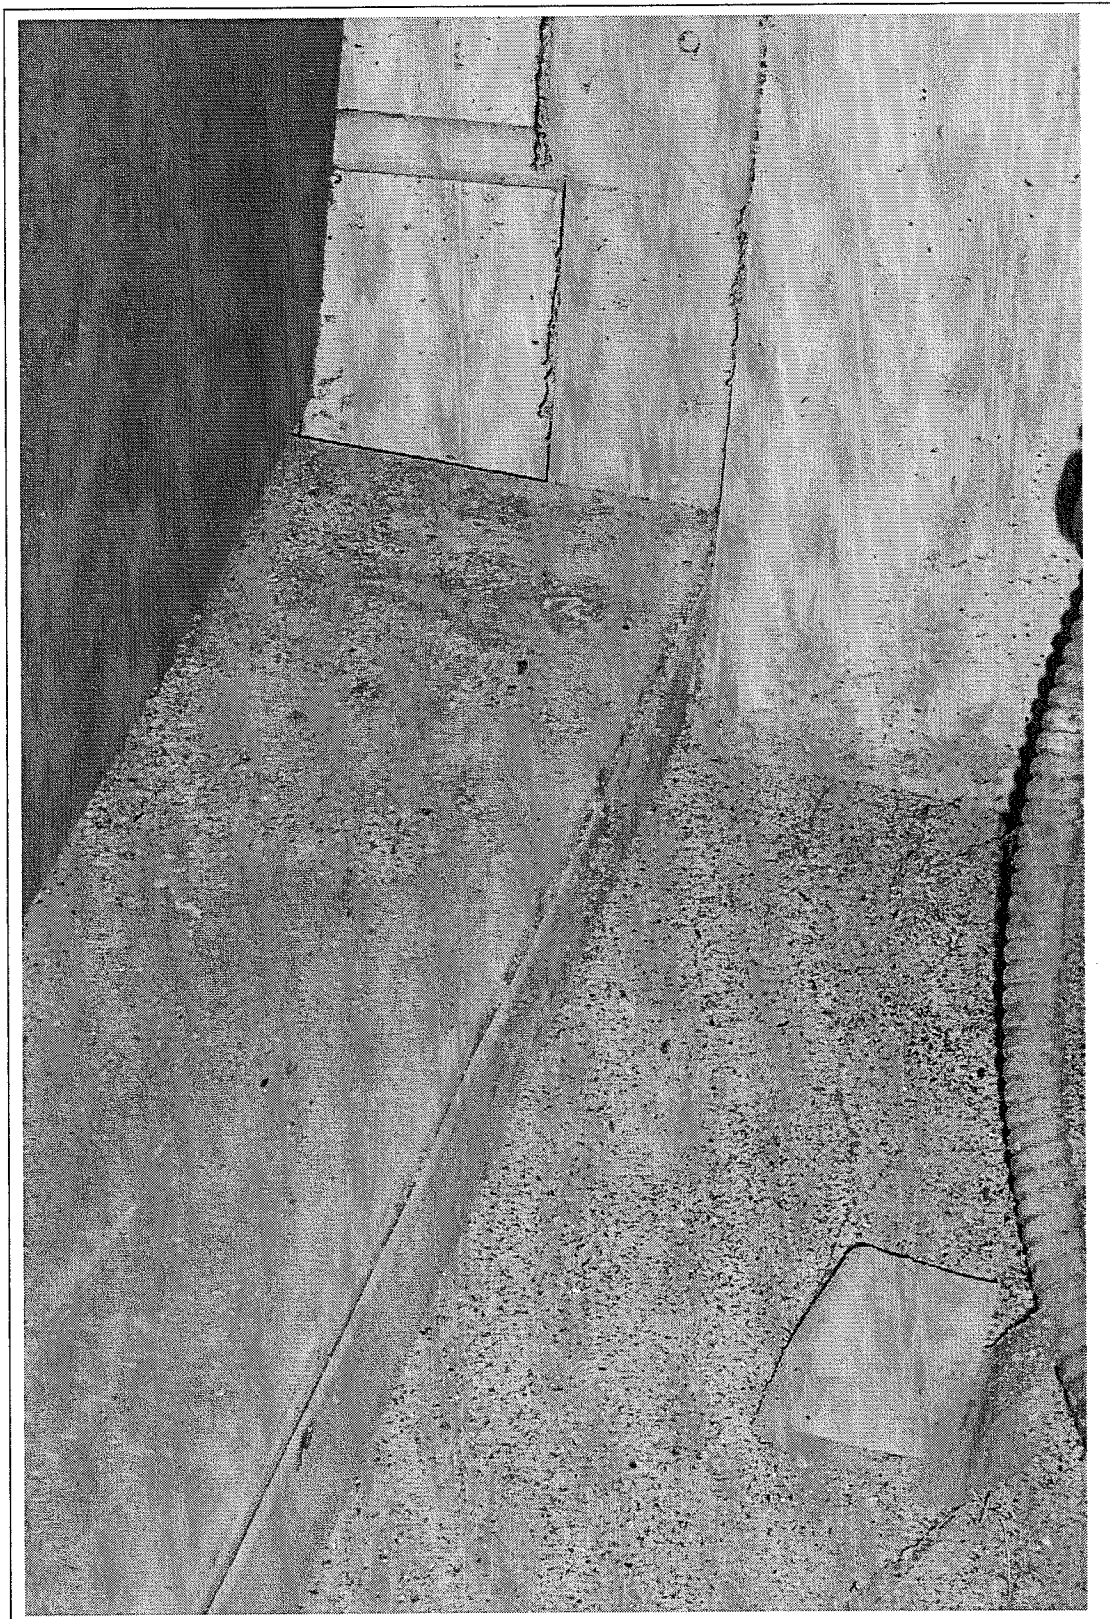
Photo 87. Main Terminal, Basement, Mechanical Rm - View of delaminated/dislodged fireproofing dust and debris on floor (in parts storage area)
